Recent Coastal Structures Asset Management Activities of the Great Lakes Districts of the US Army Corps of Engineers

Fully Integrate Asset Management into the Great Lakes Navigation System

Structural Rating for Rubble or Laid-Up Breakwaters and Jetties

PROJECT NAME: Oswego Harbor, NY		Reach: B
STRUCTURE NAME: West Arrowhead Breakwater		Sta: From 0 To 27
INSPECTION TEAM: Great Lakes Regional Breakwater Assessment Team		DATE: 23-Oct-2008
NAME:	OFFICE SYMBOL:	PHONE:
P. Bijhouwer	LRB	(716) 879-4377
M. Mohr	LRB	(716) 879-4168
S. Chader	LRB	(716) 879-4188
C. O'Connell	LRB	(716) 879-4143
T. Kroll	LRC	(716) 879-4188
T. O'Bryan	LRE	(616) 842-5510 x 25523
D. Wright	LRE	(313) 226-3573
		TIME: Begin 0700 End 1600

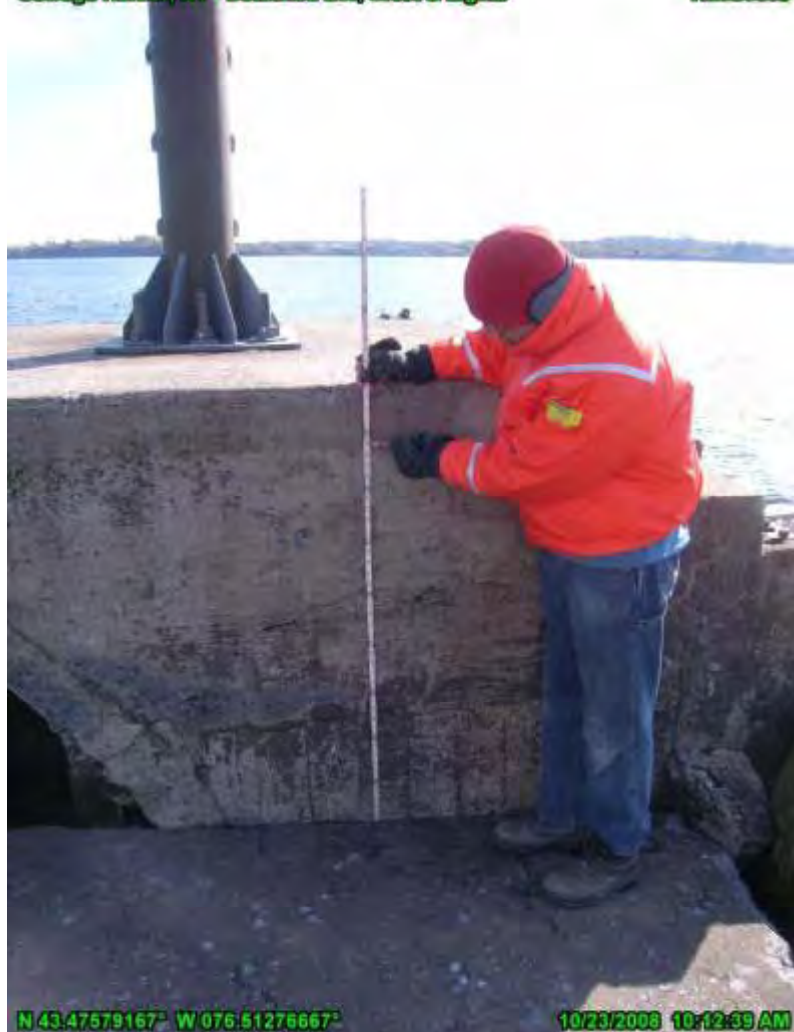
RIMG0005

Elevation/Alignment Rating = 5 (settlement, loss of design crest height)

Oswego Harbor, NY - Detached BW, Crest & Lights

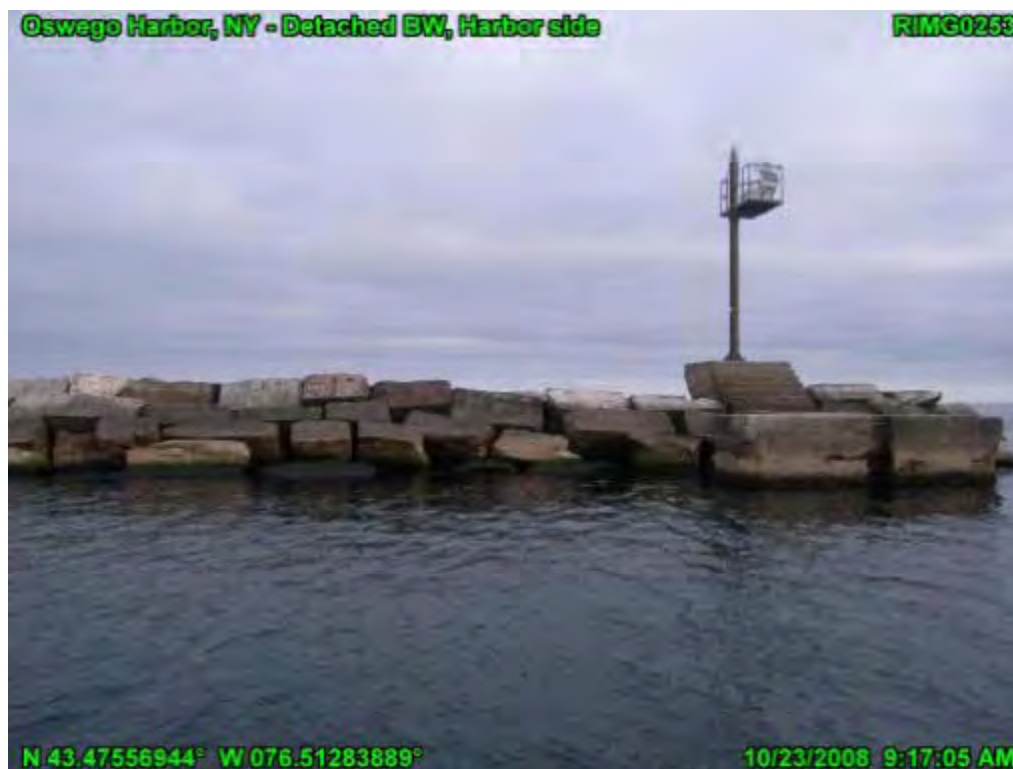
RIMG0253

Oswego Harbor, NY - Detached BW, Harbor side

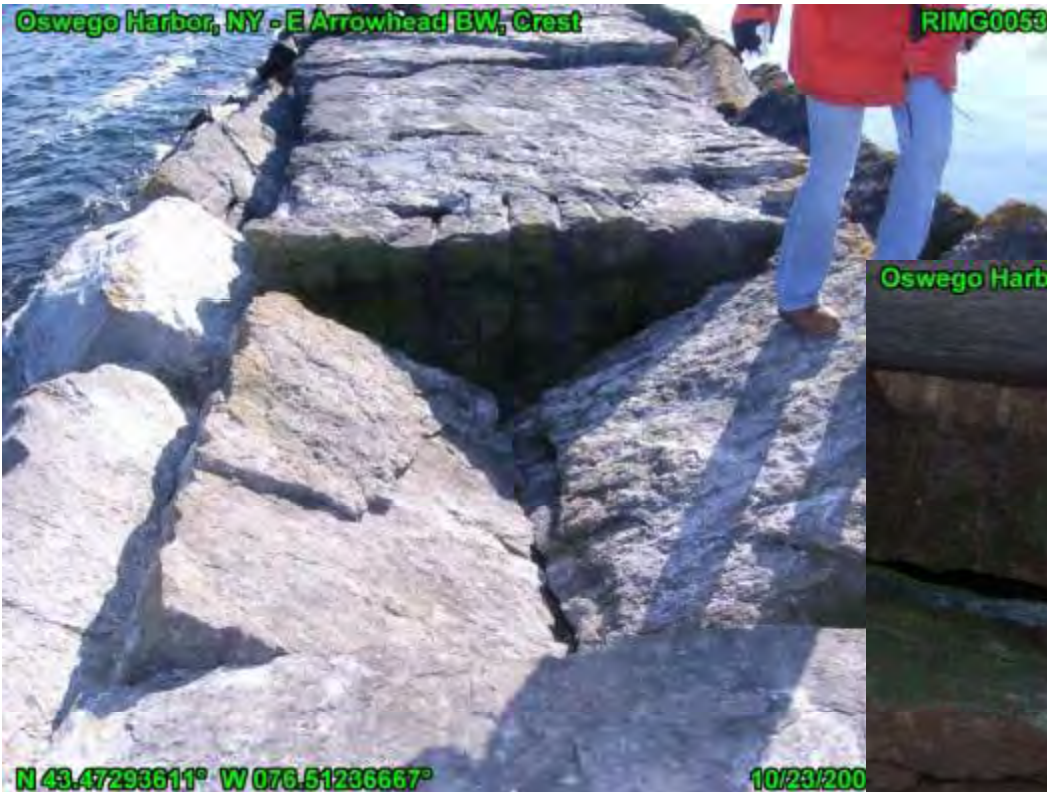
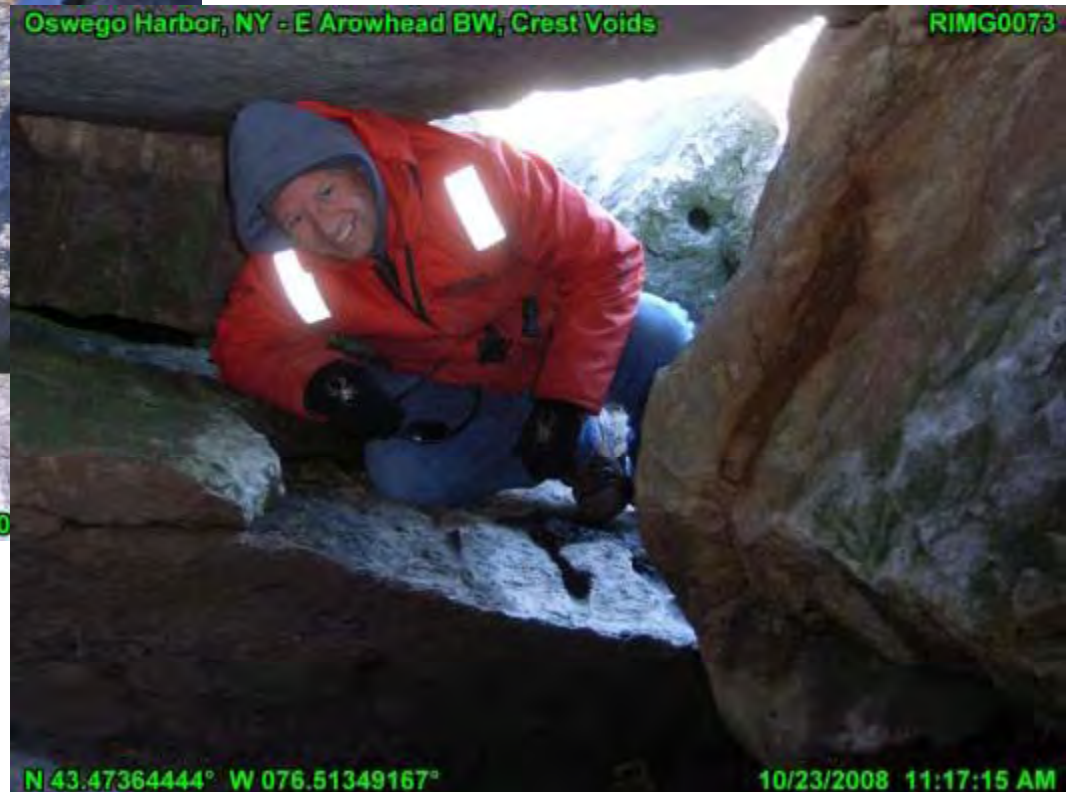
Fill Stone Rating = 5 (complete loss of fill stone)

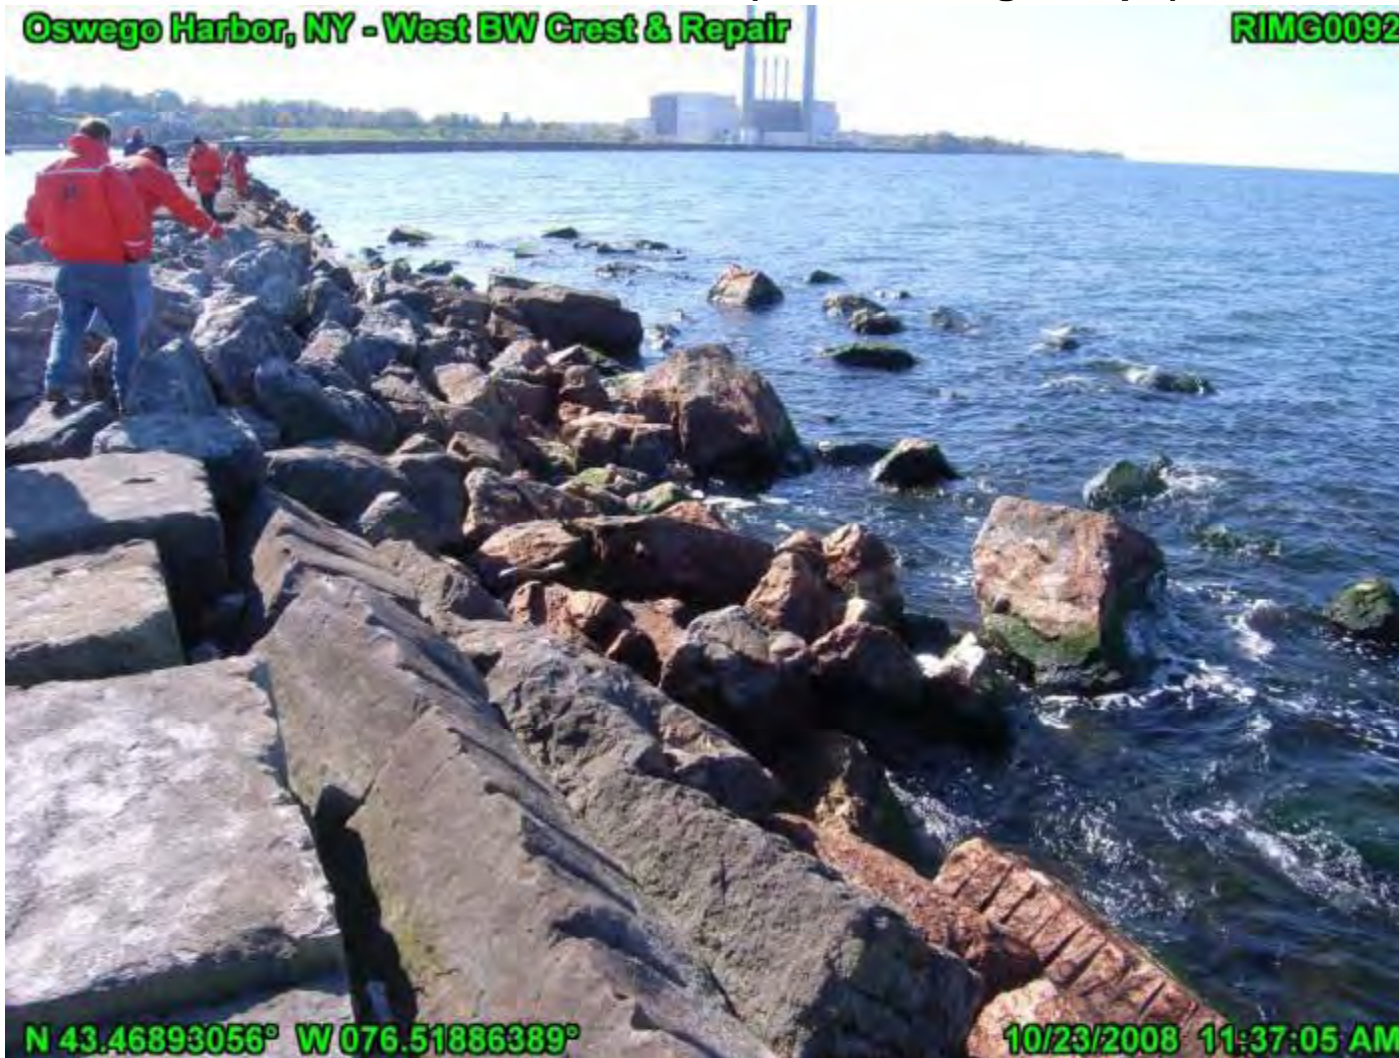
RIMG0092

Scour/Wave Protection = 4 (loss of design slope)

Oswego Harbor, NY - West BW Crest & Repair

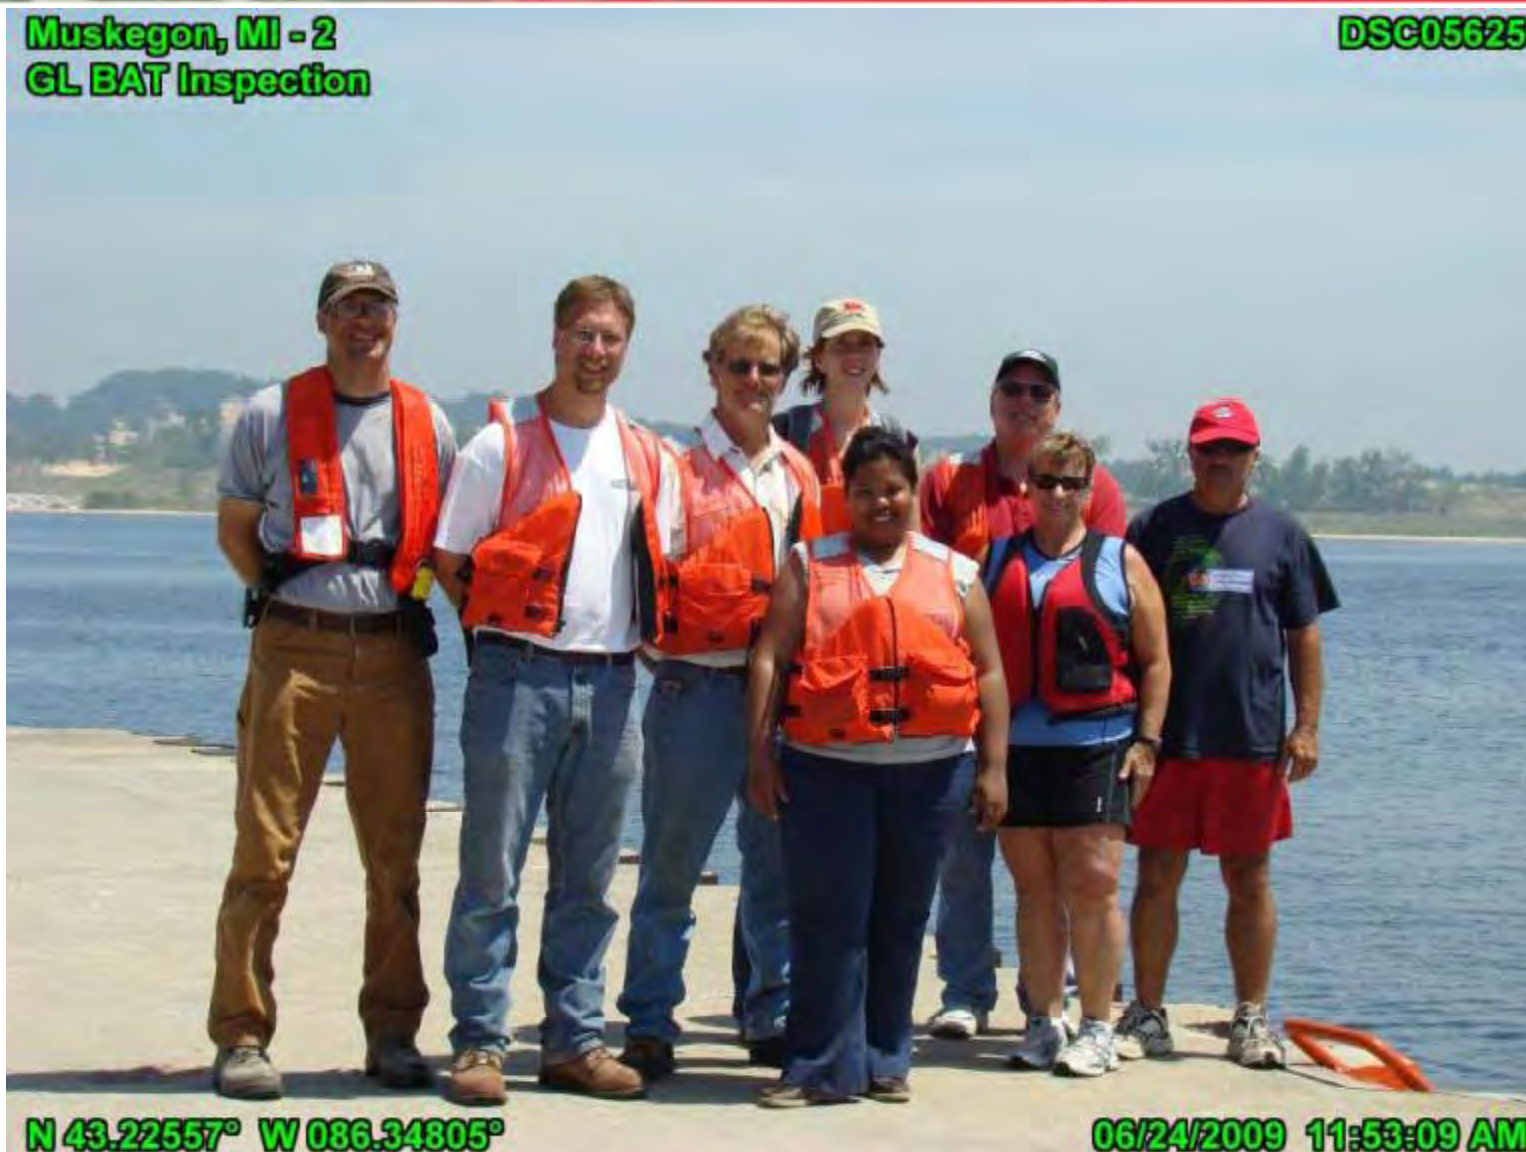
DSC05625

Muskegon, MI - 2
GL BAT Inspection
